# HISTORIC STRUCTURAL ASSESSMENT

THE LOUISVILLE CABOOSE

1155 PINE STREET, LOUISVILLE, COLORADO

August 13, 2025

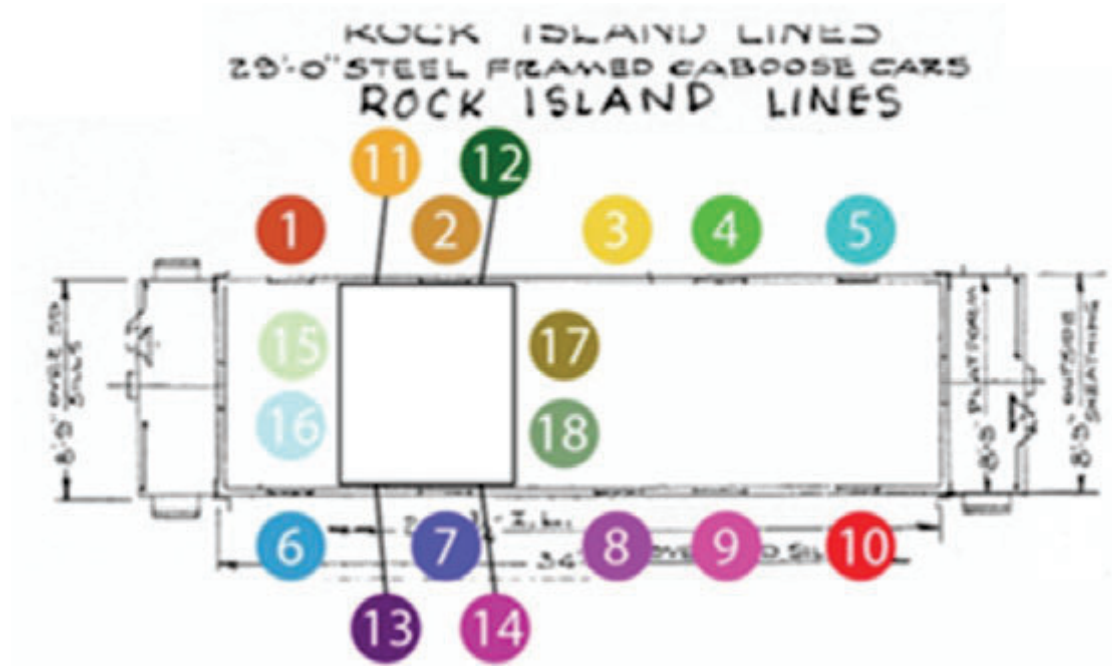
All windows were originally constructed of traditional wood framing seen in most railcars from the 1940s-era (when The Louisville Caboose was converted into a caboose). The windows are each set into the wood cladding on the body of the caboose (or in the case of the cupola, into the steel framing of the cupola). As shown in the following illustrations, there are 18 windows total, and they are of the fixed-window type. There are also two doors - one on each end, as shown in the photos. The doors are typical of railcars of the era - narrower than you'd find in residential use to accommodate the size of the railcar. They are set within the door frames, and currently inoperable as they are screwed shut to keep the building safely sealed off.

Poor. All windows are missing, and require full reconstruction. While the doors and door frames are generally intact and structurally sound, they also require restoration including refinishing, new windows and reglazing, and hardware replacement.

(Diagram showing window locations for The Louisville Caboose)

1. Applicant saved one full, intact window to use as a template, and our recommendation is to use this template to have new windows constructed to emulate the original ones in fit and finish.
2. Also recommend removal and restoration of both doors with new windows and hardware. Use tempered glass where required for both doors and windows.  
Note: Replace windows only after siding is replaced and they are appropriately located as per original specifications. Applicant may consider replacing original fixed-windows with period-correct styled windows that have a functional swing-out ability to better facilitate future adaptive re-use of the structure.

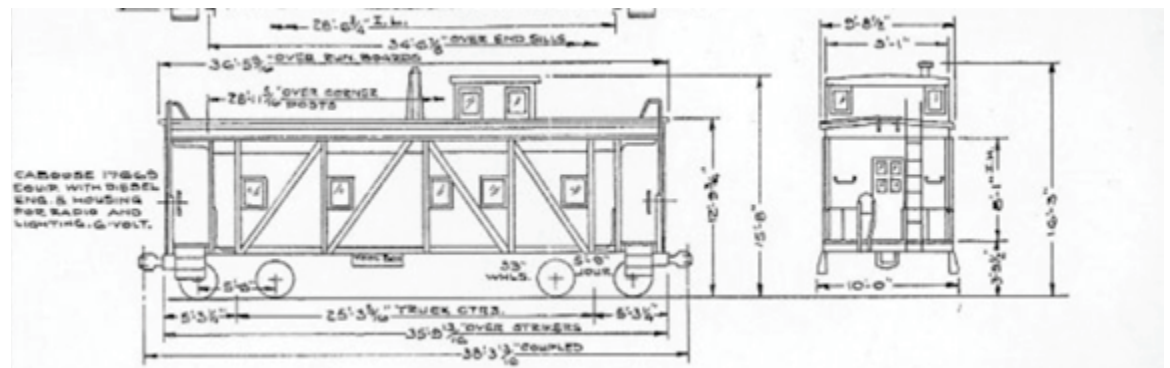
*(Second diagram showing window locations for The Louisville Caboose from the original blueprints)*

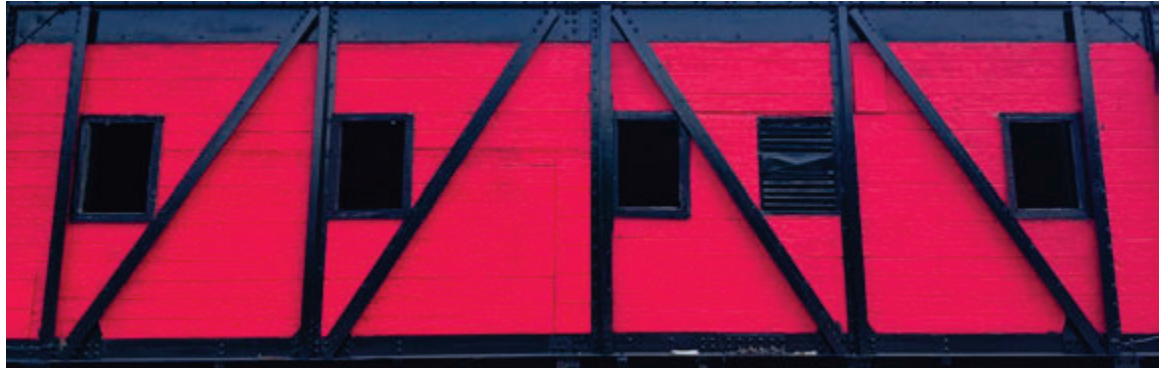
*(Close up of windows on Northwest side of caboose)*

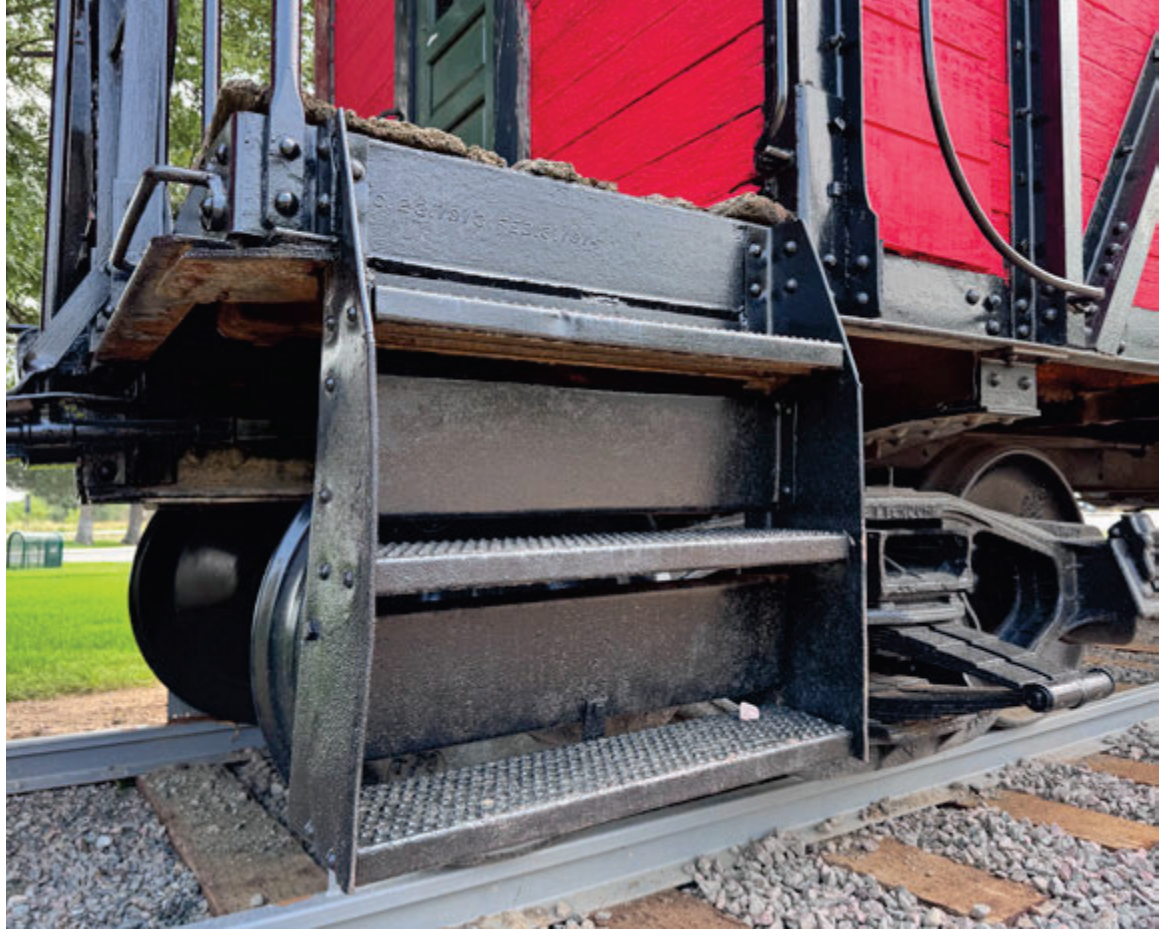
Three of four corner step-up ladders are missing and will require reconstruction to match the original fit and finish.

*(The one remaining step ladder on The Louisville Caboose)*

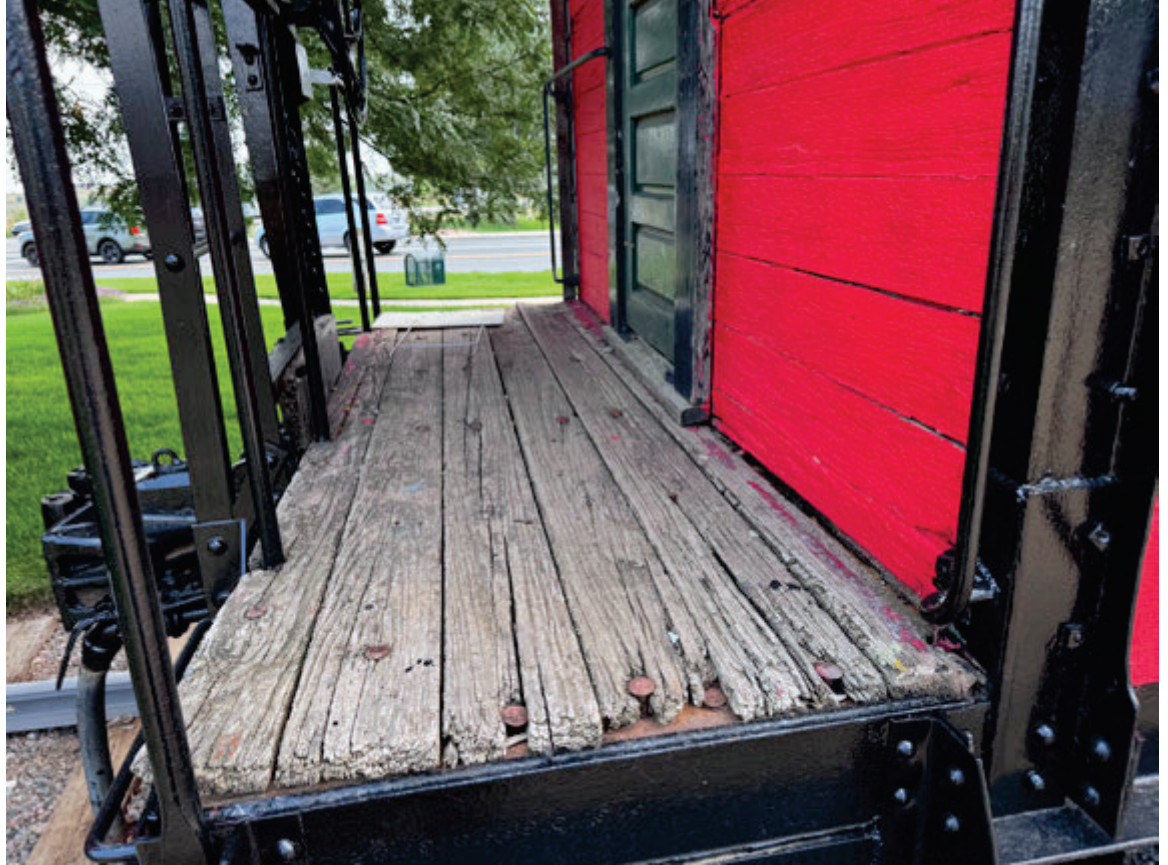
*(Northeast Platform base on The Louisville Caboose)*

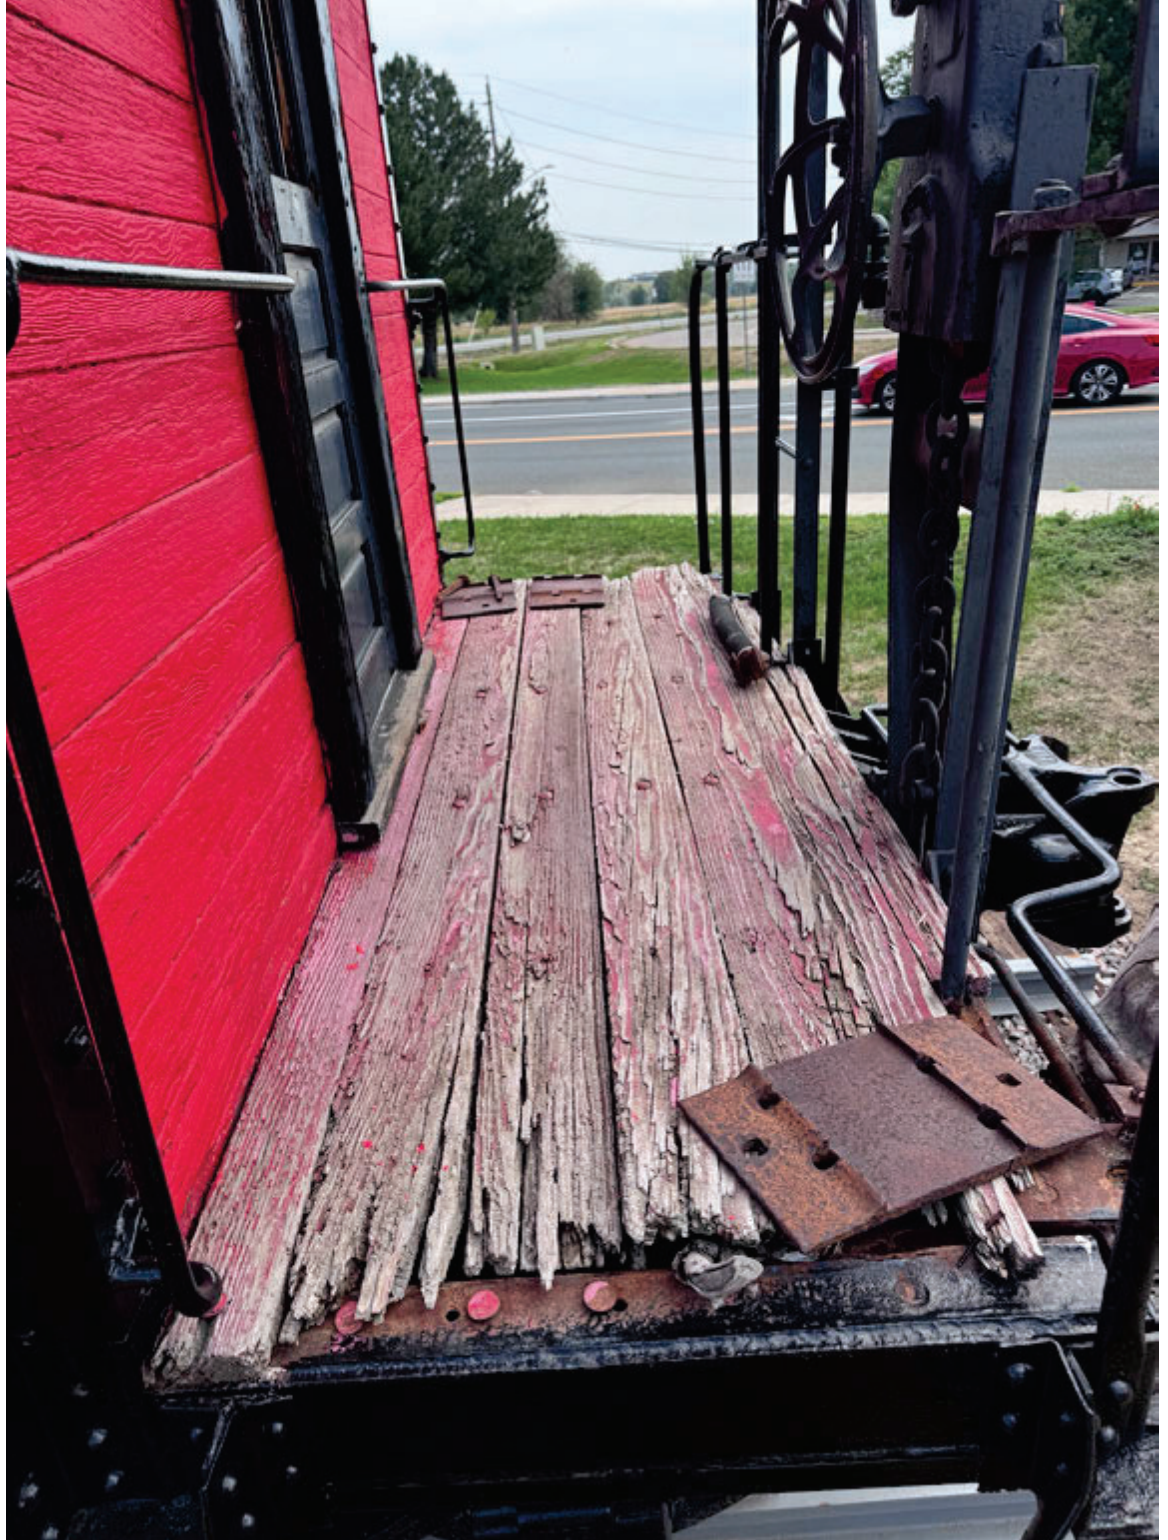
*(Southwest Platform base on The Louisville Caboose)*

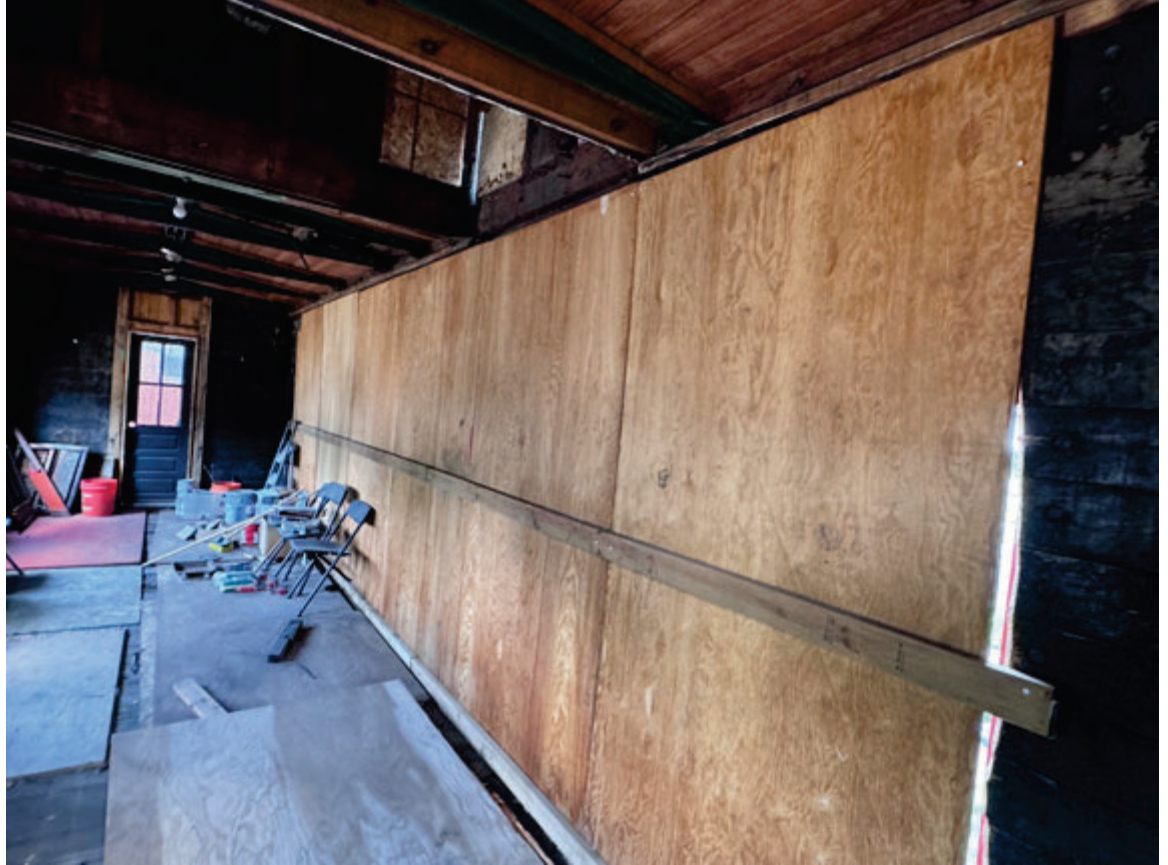
*(Interior shot, southeast wall of The Louisville Caboose)*

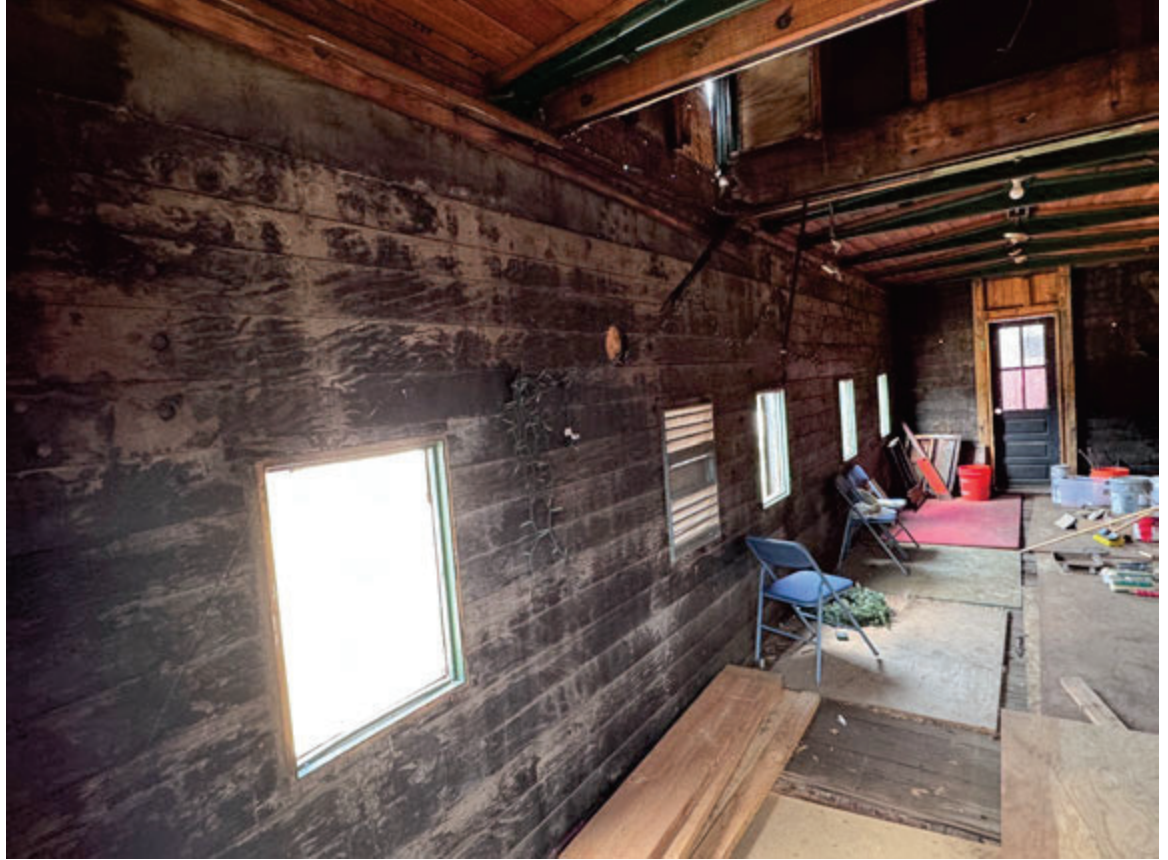
*(Interior shot, Northwest wall of The Louisville Caboose, showing original wood cladding)*

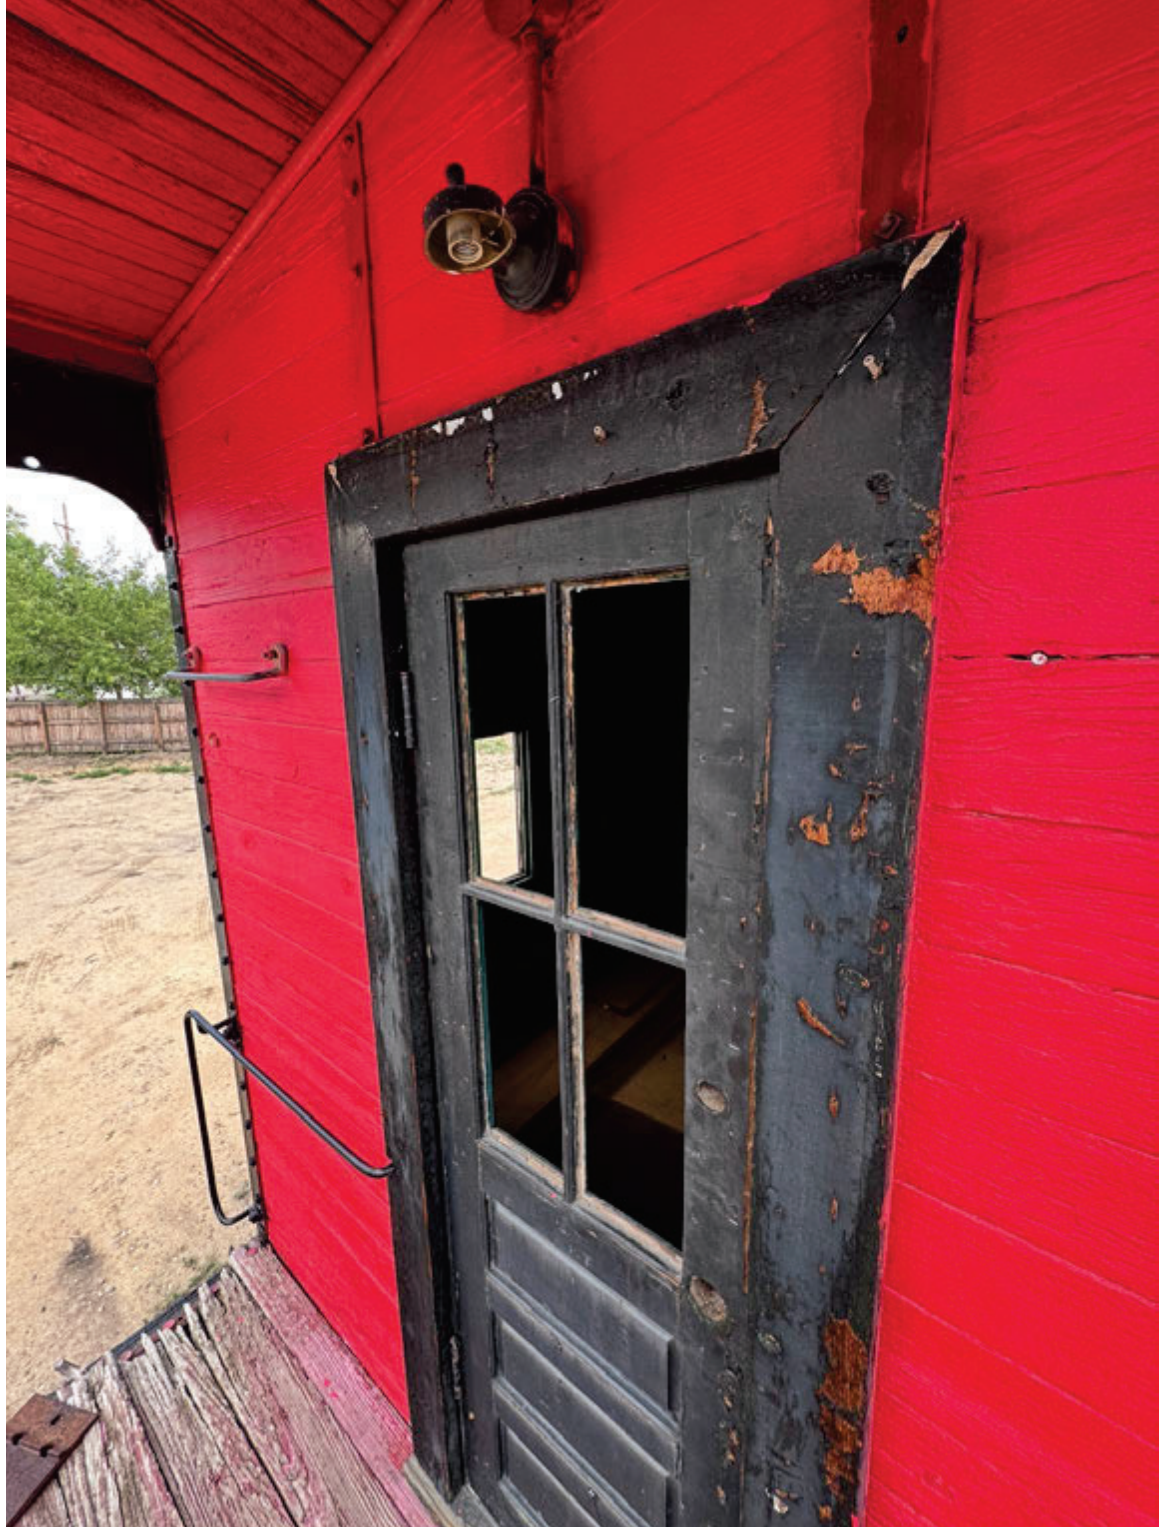
*(Door on South side of The Louisville Caboose)*

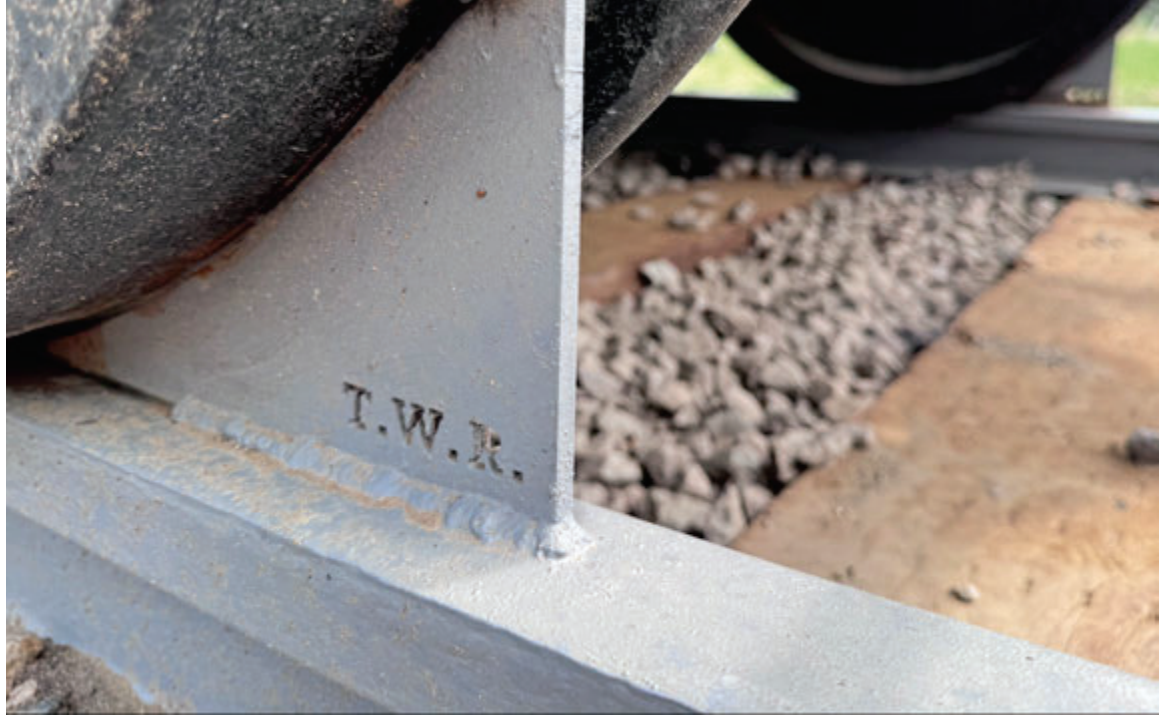
*(Detail showing welded connection between wheels and train tracks of The Louisville Caboose. Applicant had these pieces laser cut with each his children's initials as shown above)*

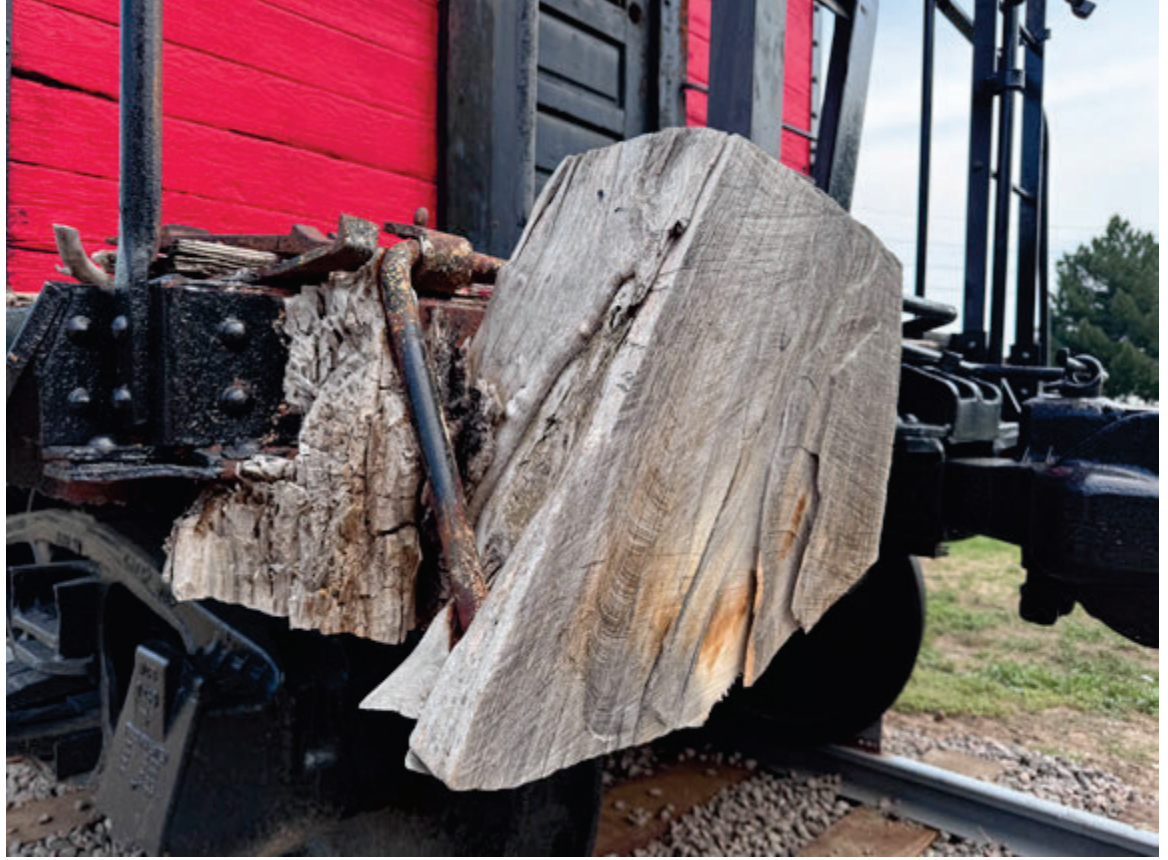
*(Platform on South side of The Louisville Caboose showing the remnants of the trunk of a tree that had grown around the corner of the caboose while it was at Main St. & South Boulder Rd. location)*

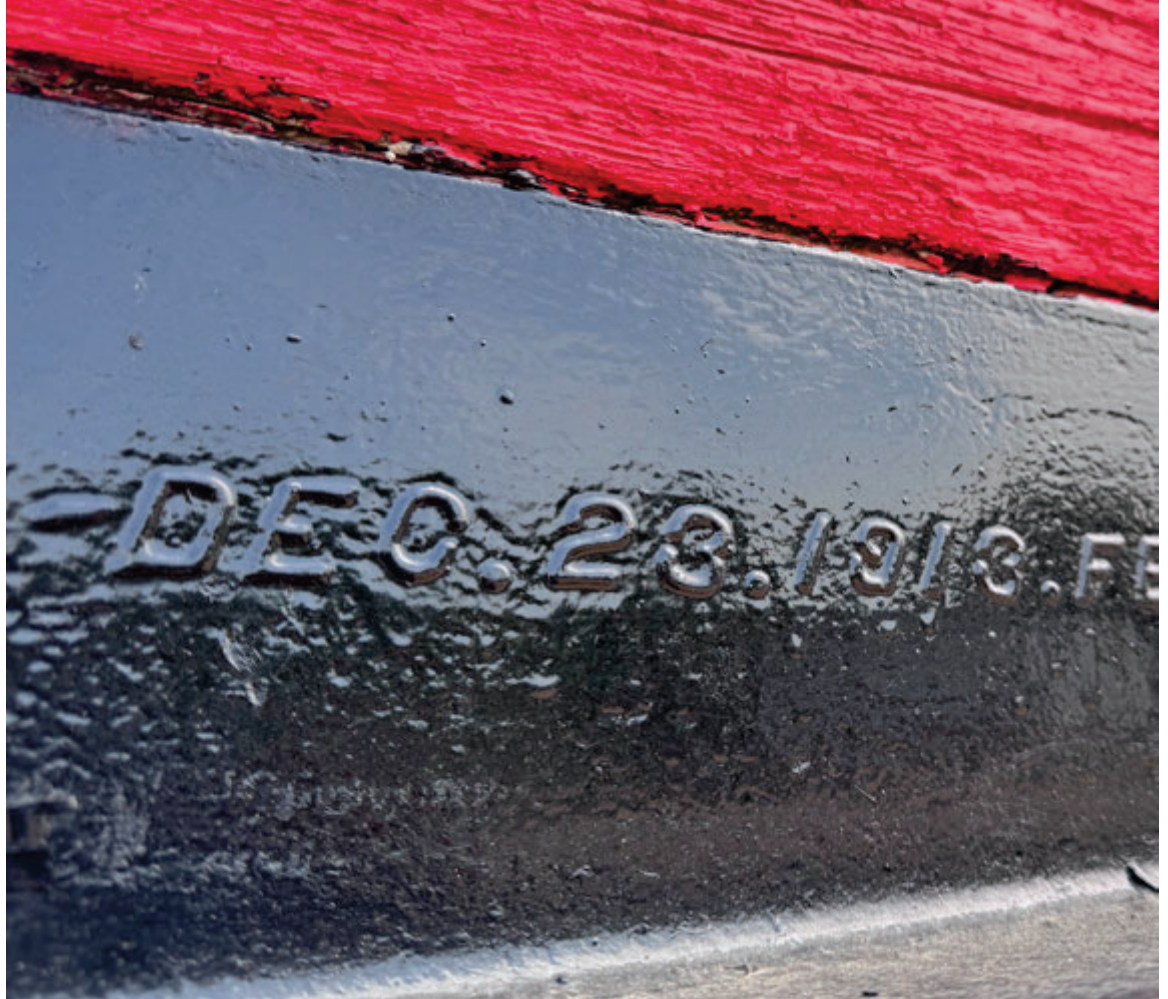
*(Detail on one of the structural beams on the side of The Louisville Caboose, dated Dec. 23, 1913)*

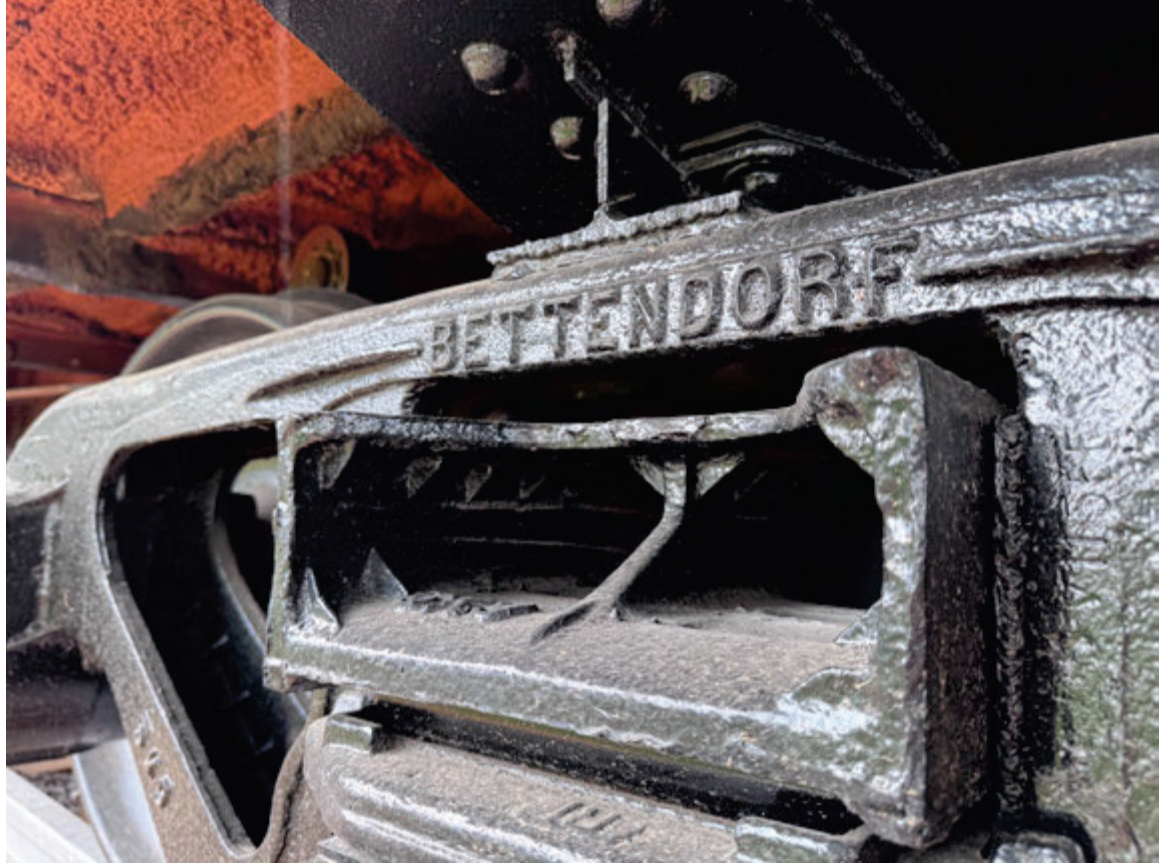
*(Detail of 'Bettendorf' trucks under The Louisville Caboose)*
