Klarr Locomotive Industries GP20E #2003 Inspection

Performed By Maxfield & Carlson Enterprises, LLC

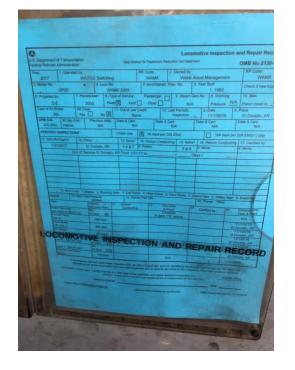
Blue card shows out of service since 1/31/17 and last air dates 11/1/16.
