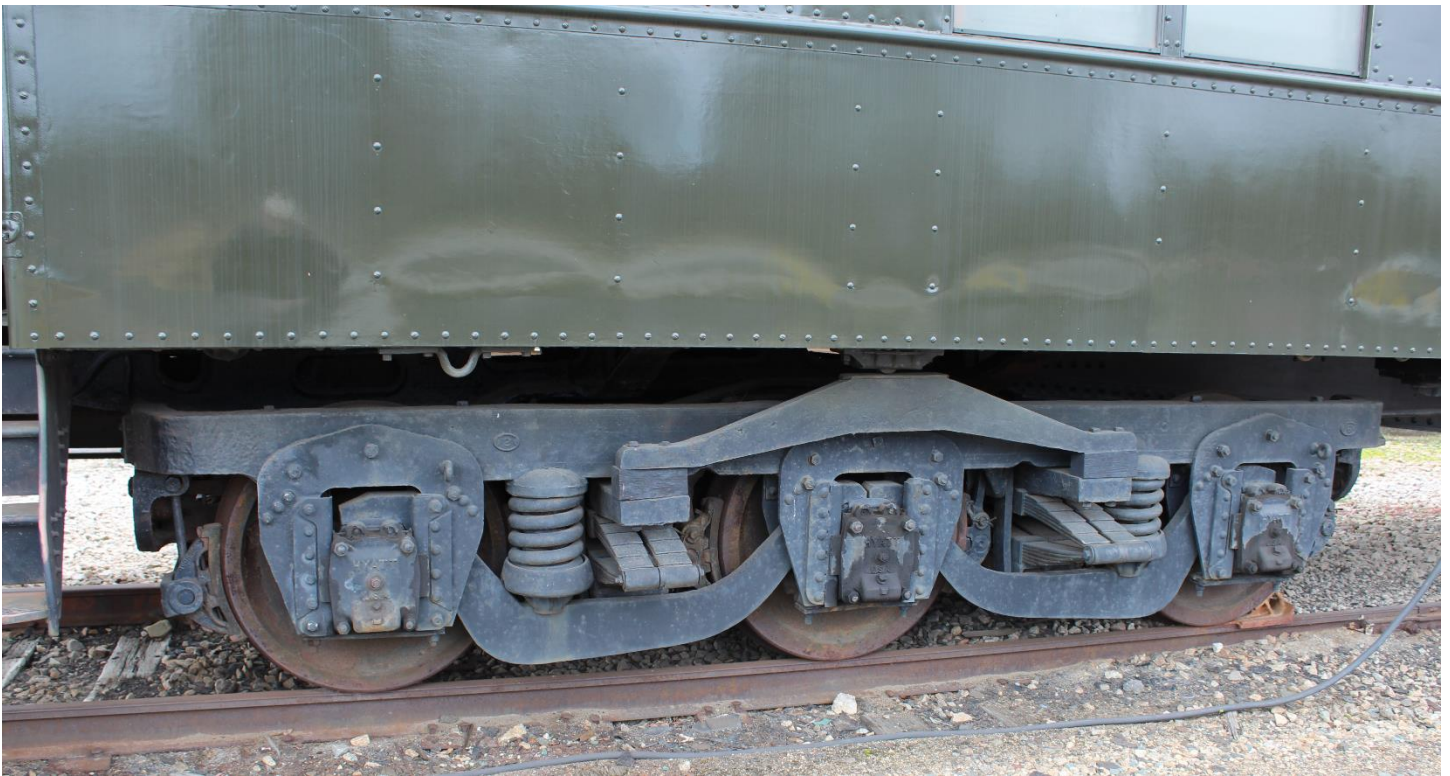
Truck Assembly – Men's room end. Friction Bearings replaced with Hyatt roller bearings in 2000.

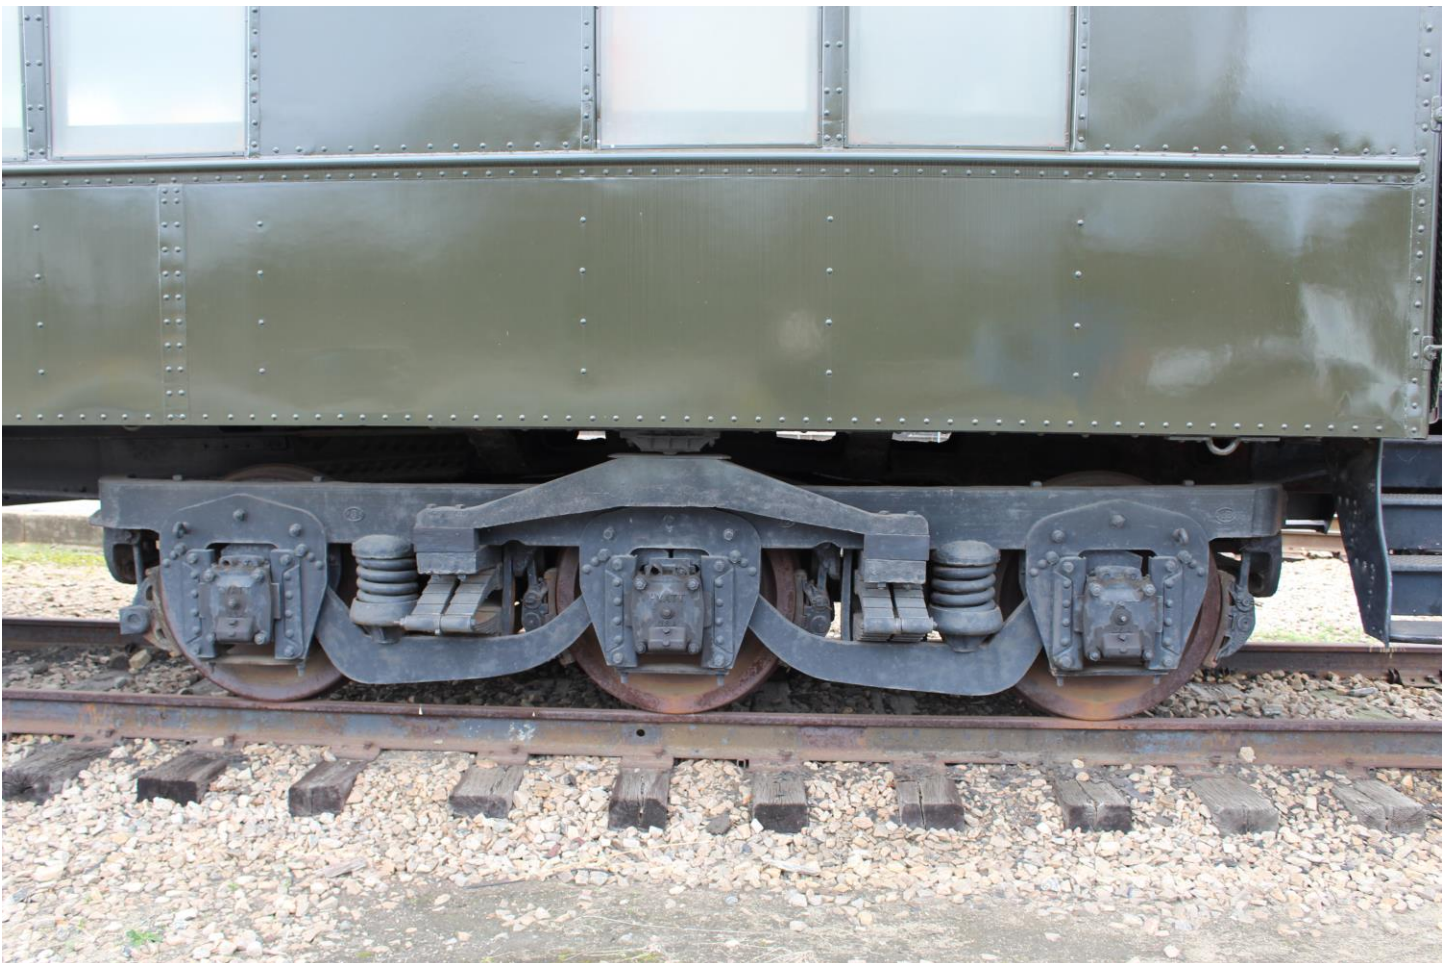
Truck Assembly under the Ladies Room end.

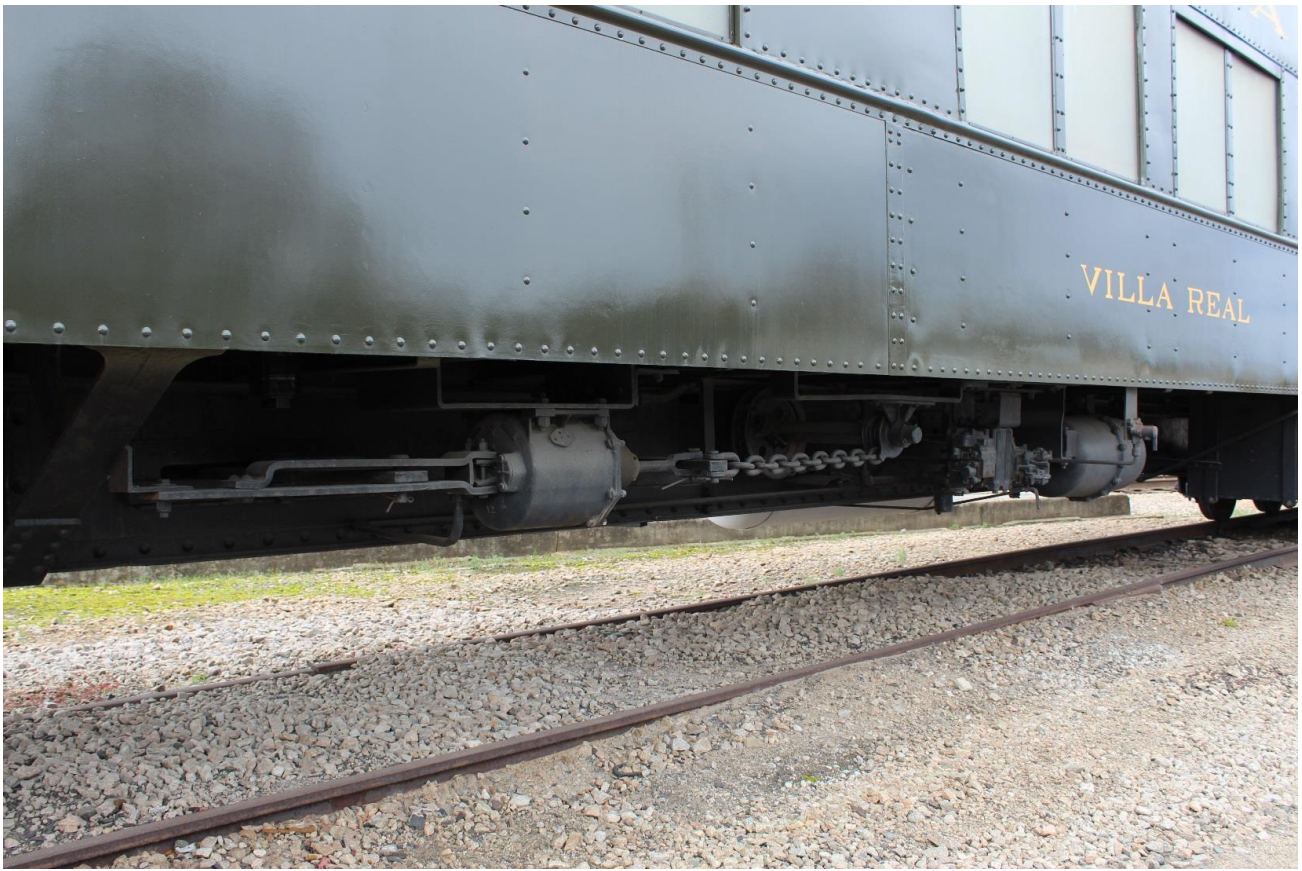
12" single brake cylinder, ABD break valves and reservoir.

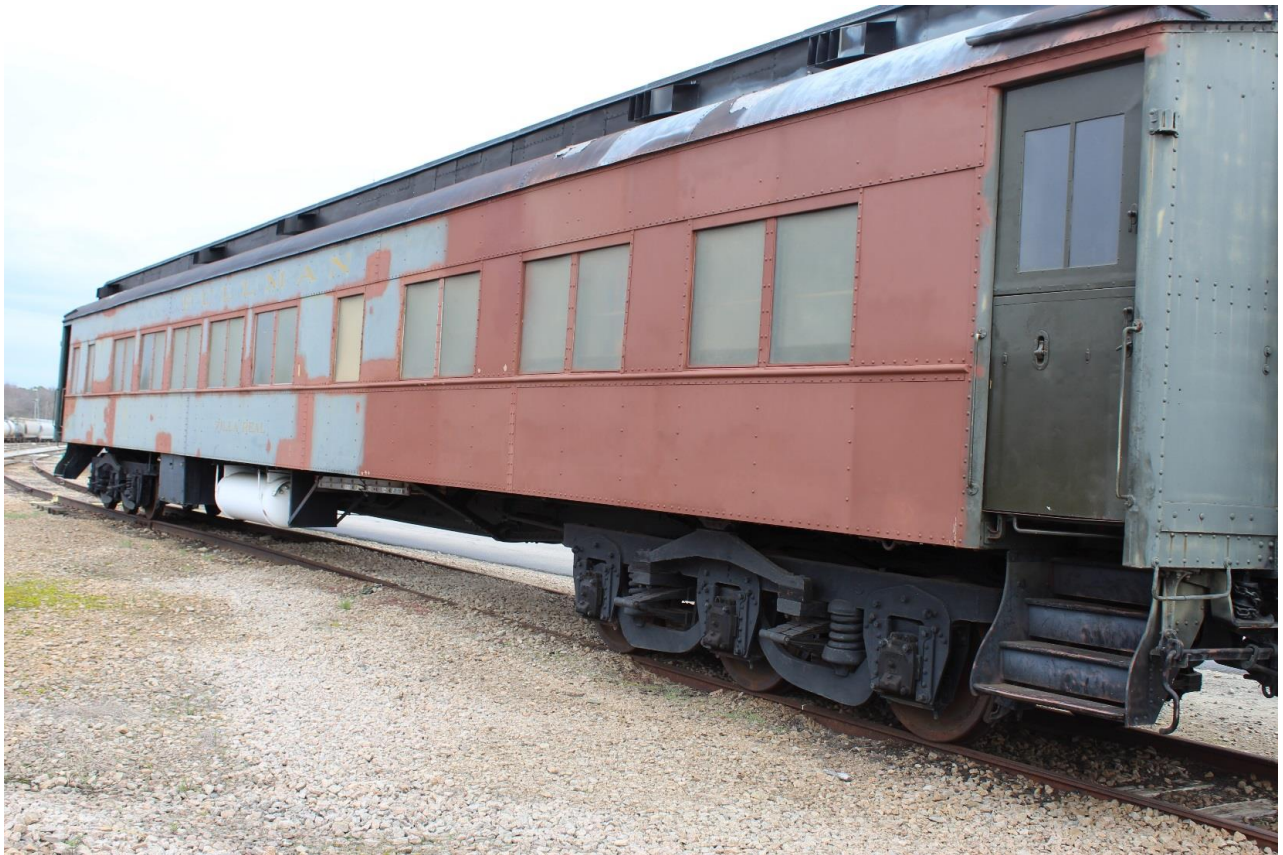
West side of the car with repainting in process. On hold for the winter.

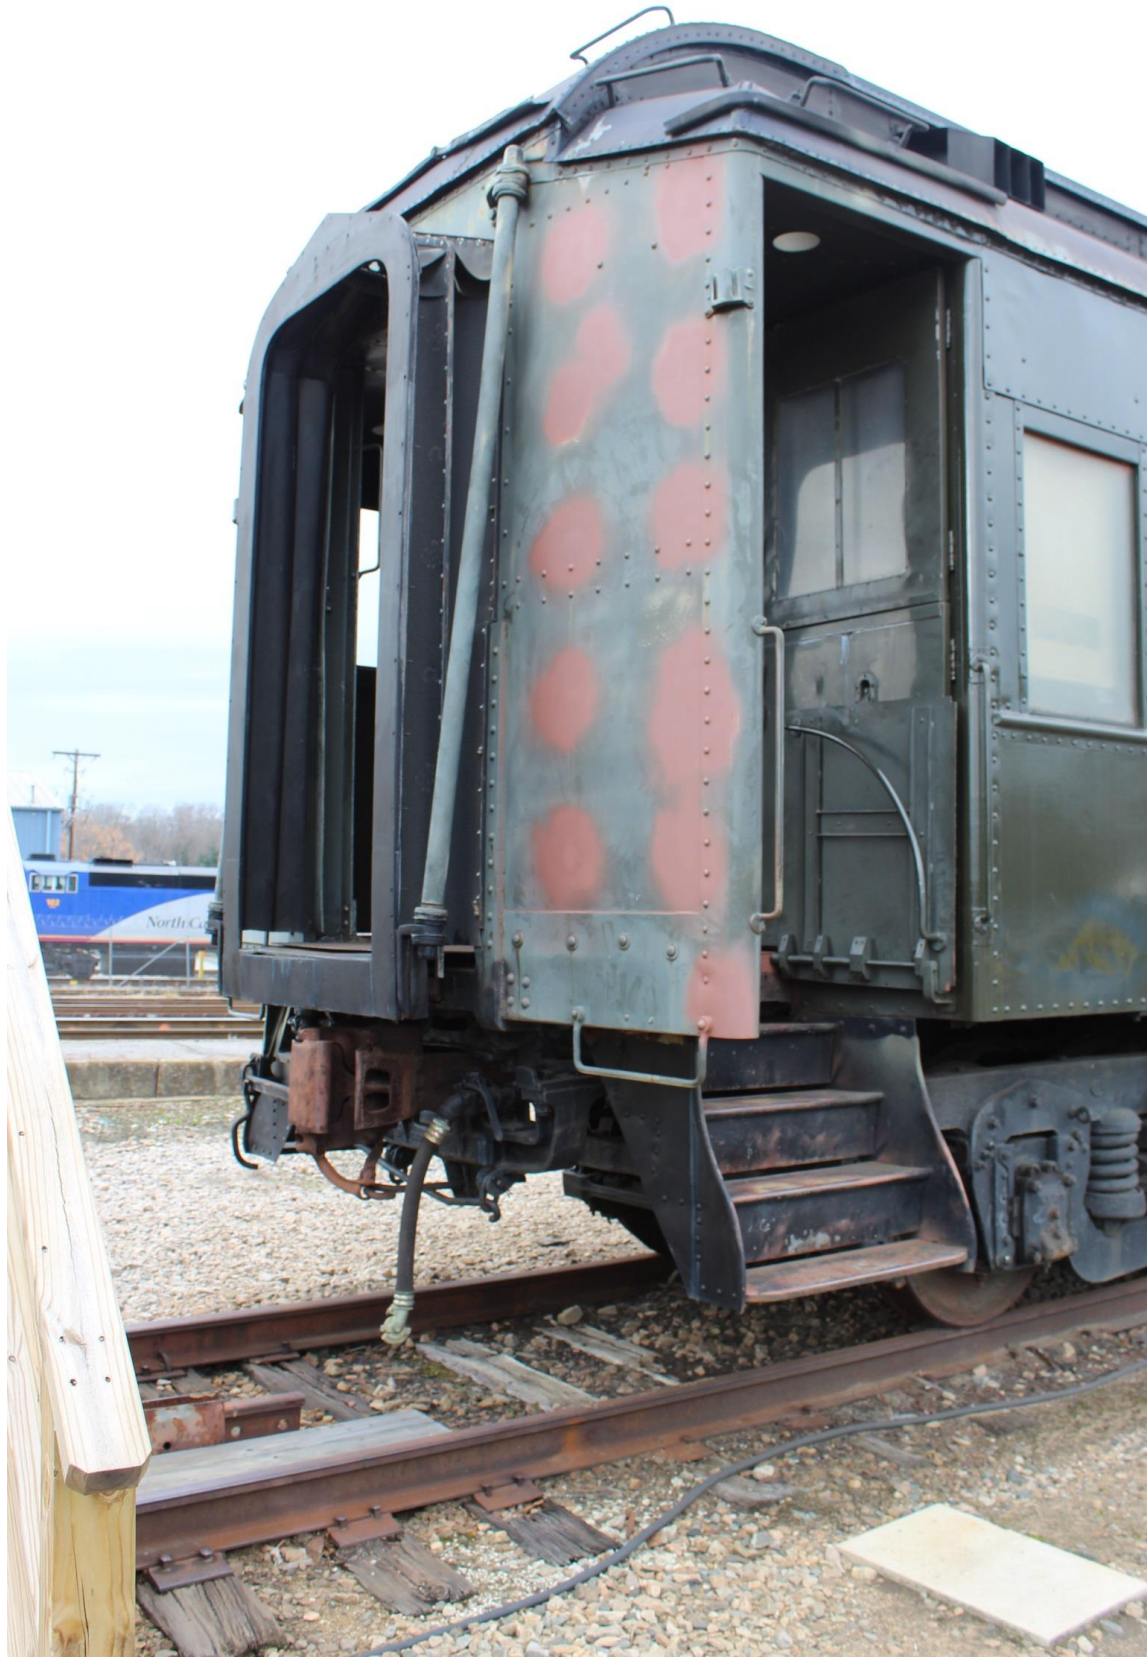
Vestibule on Men's room end of the car. The primer spots are where grab irons had been in place from MOW days. The holes have been welded shut and awaiting new paint.

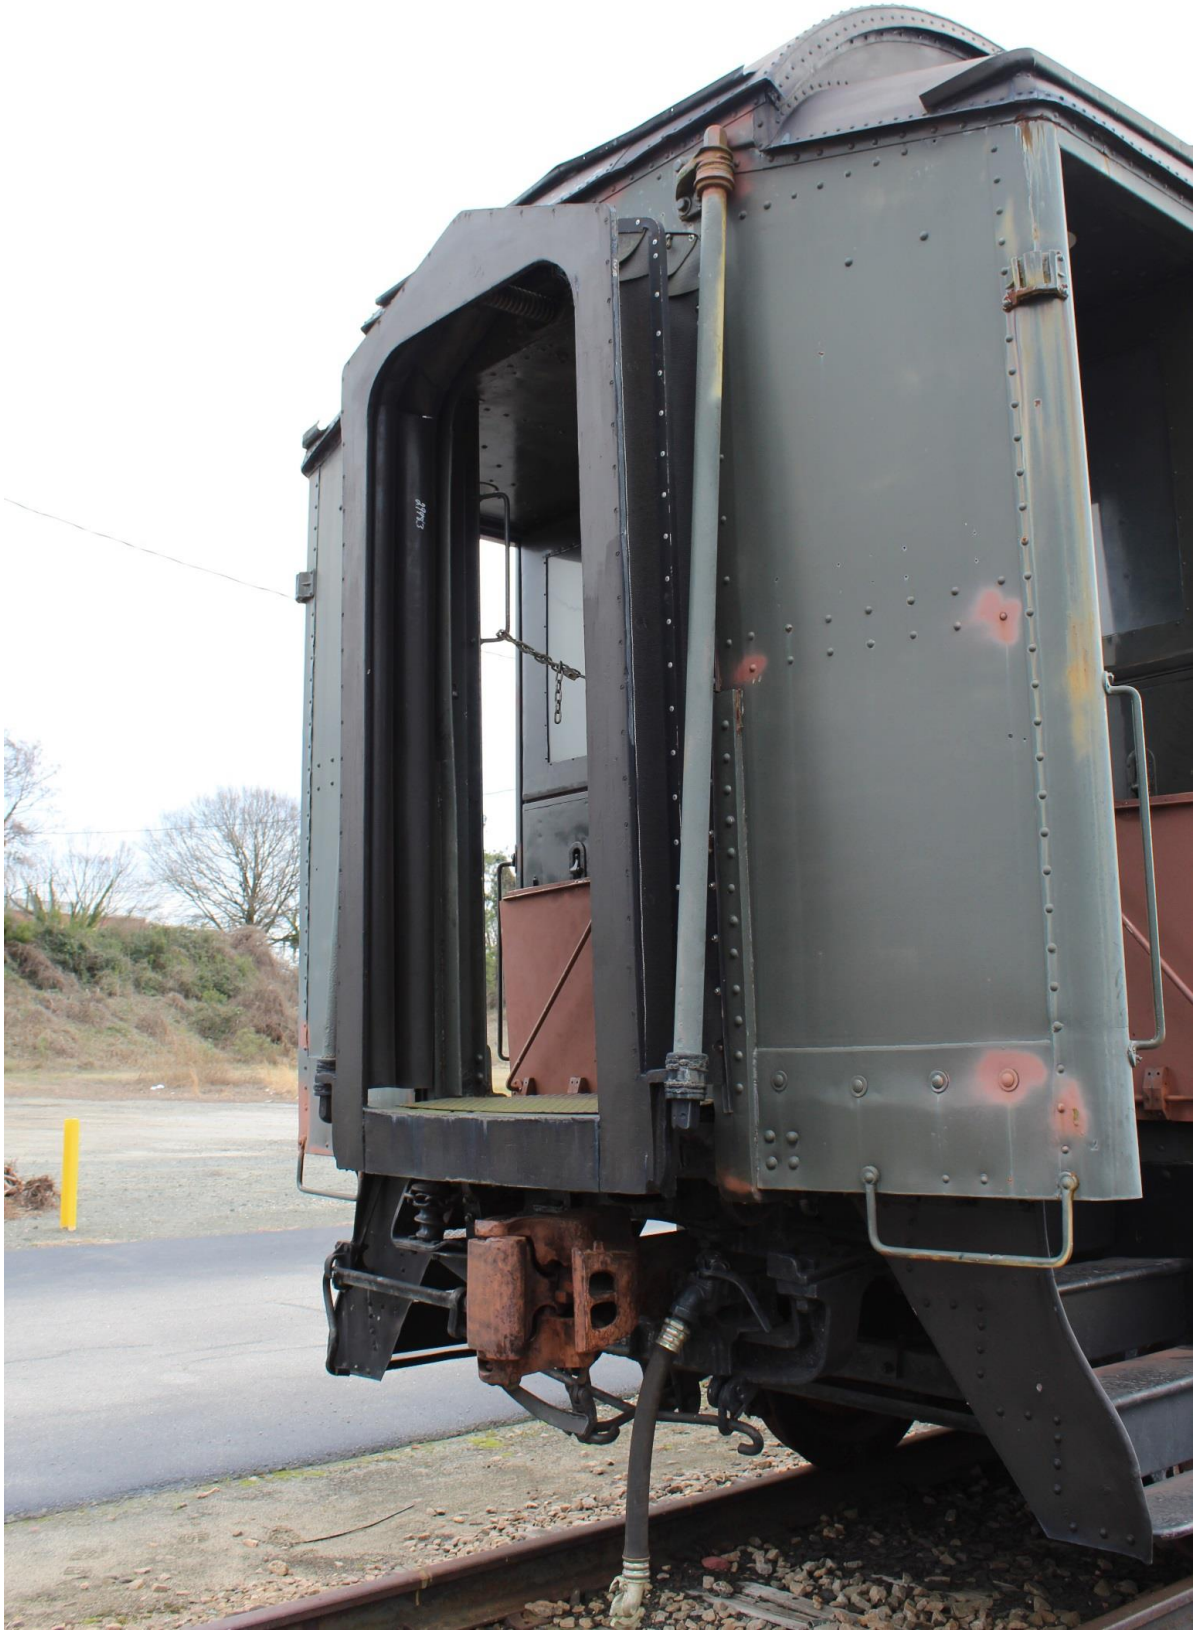
Vestibule on the Ladies room end of the car.

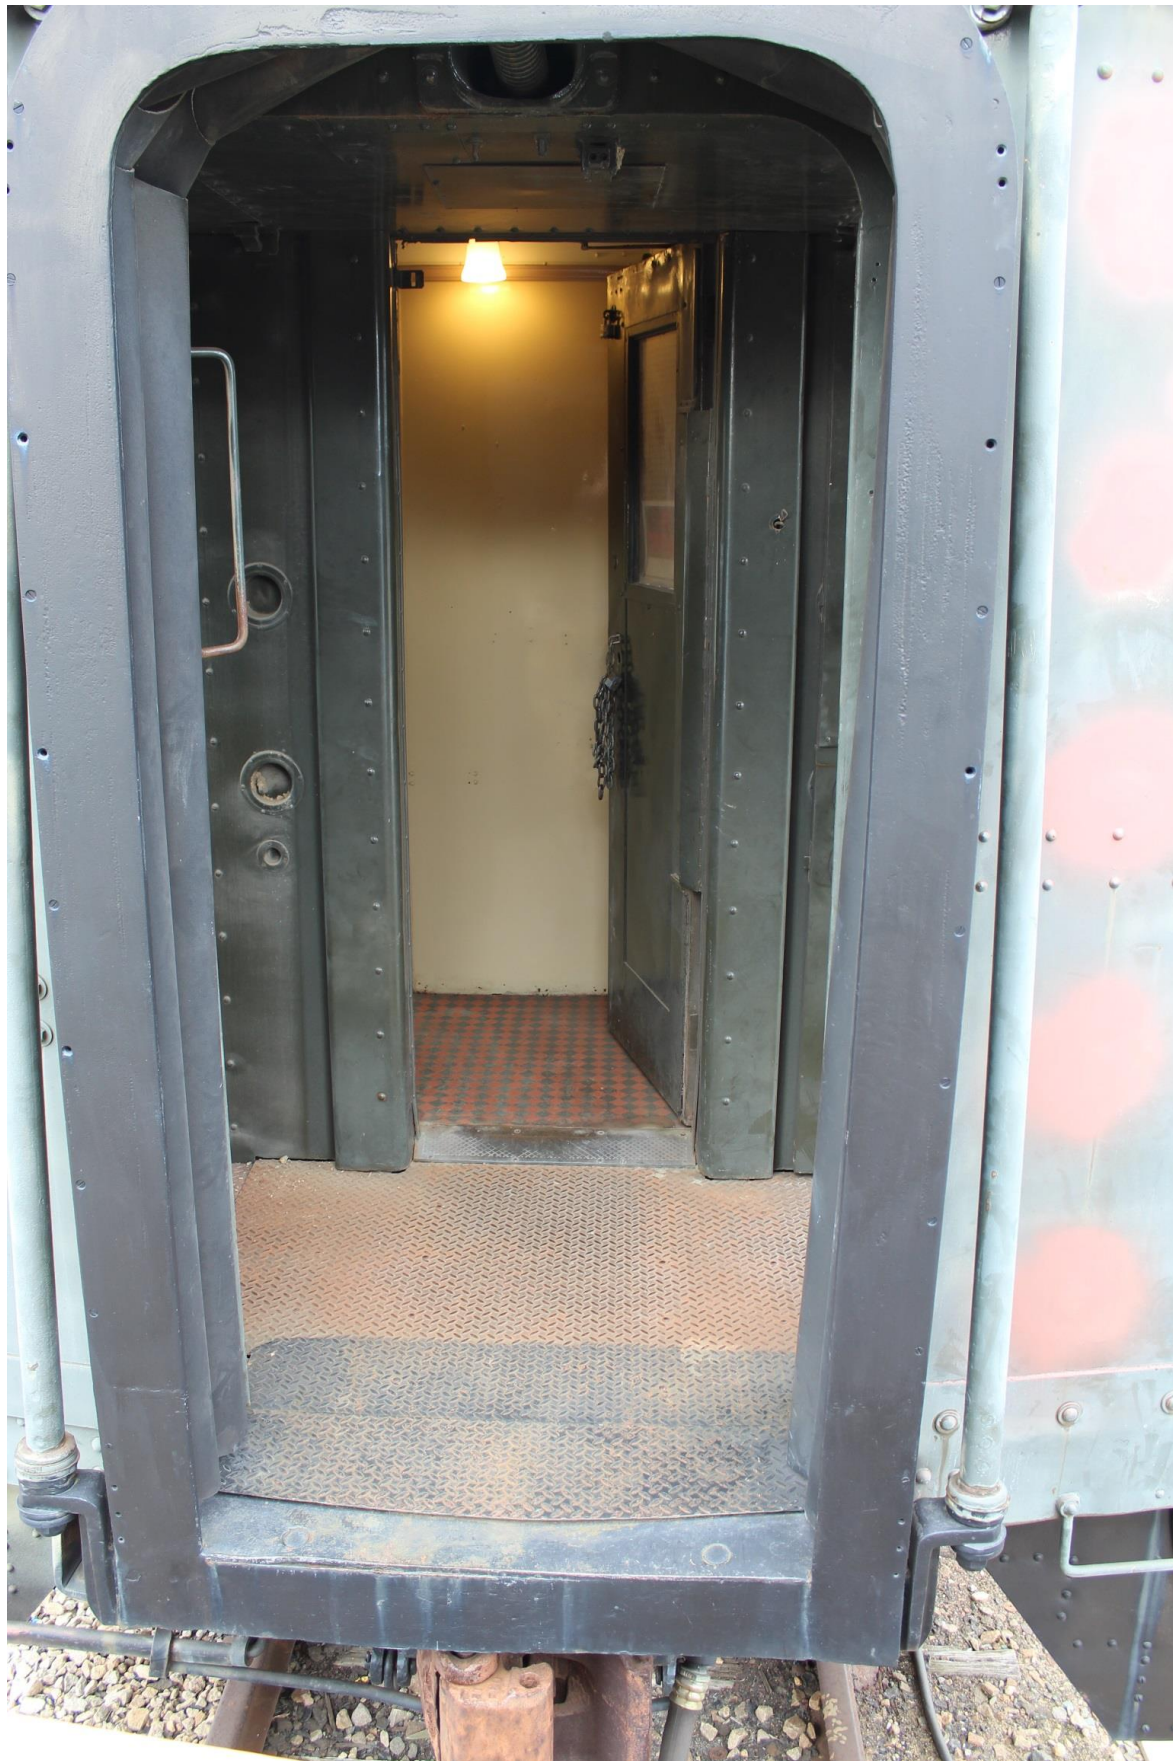
Entry hallway and vestibule platform on the Men's room end of the car. The red/black check flooring is the original from 1911. Steel grid plate installed on the platform to replace the open grid roof walk used during MOW. Buffer plates added in 1997. Buffer curtains fabricated and added in 2001.

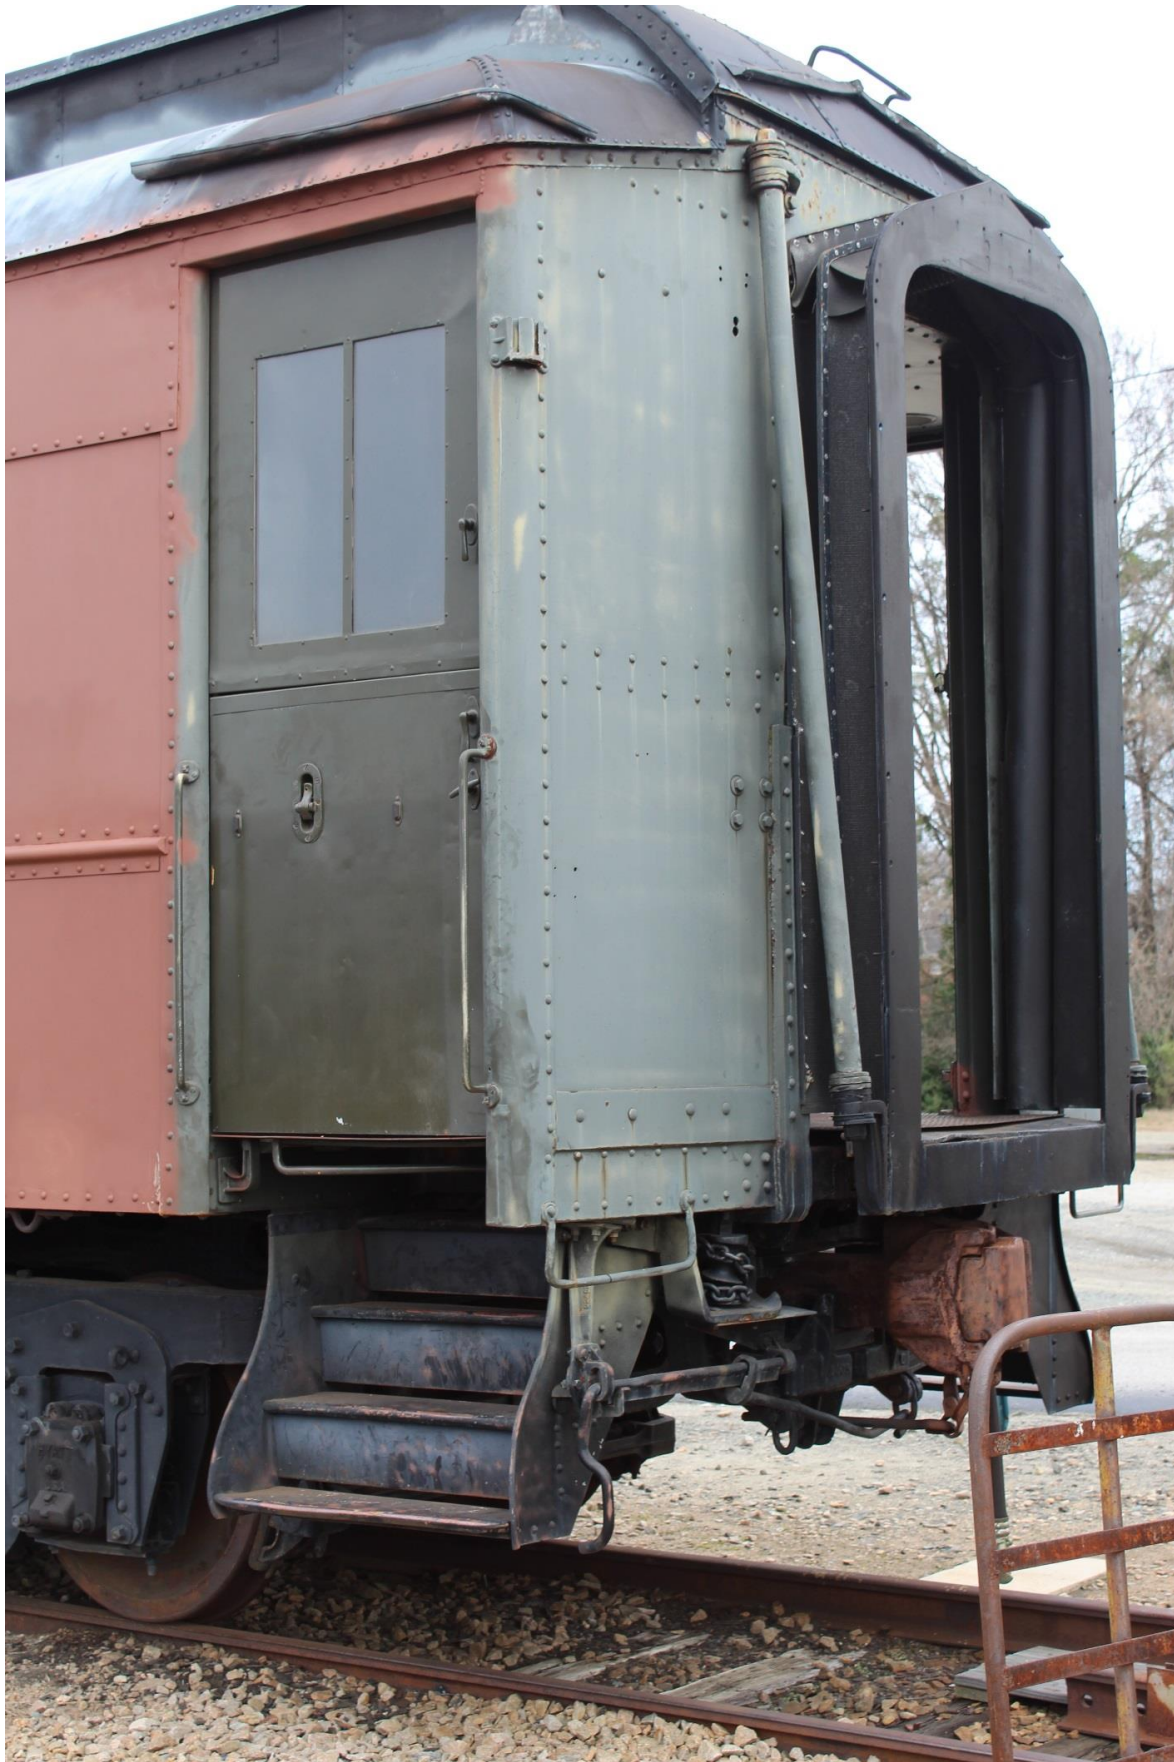
Dutch door in the closed position on the Men's room end of the car. All Dutch doors are similarly restored.

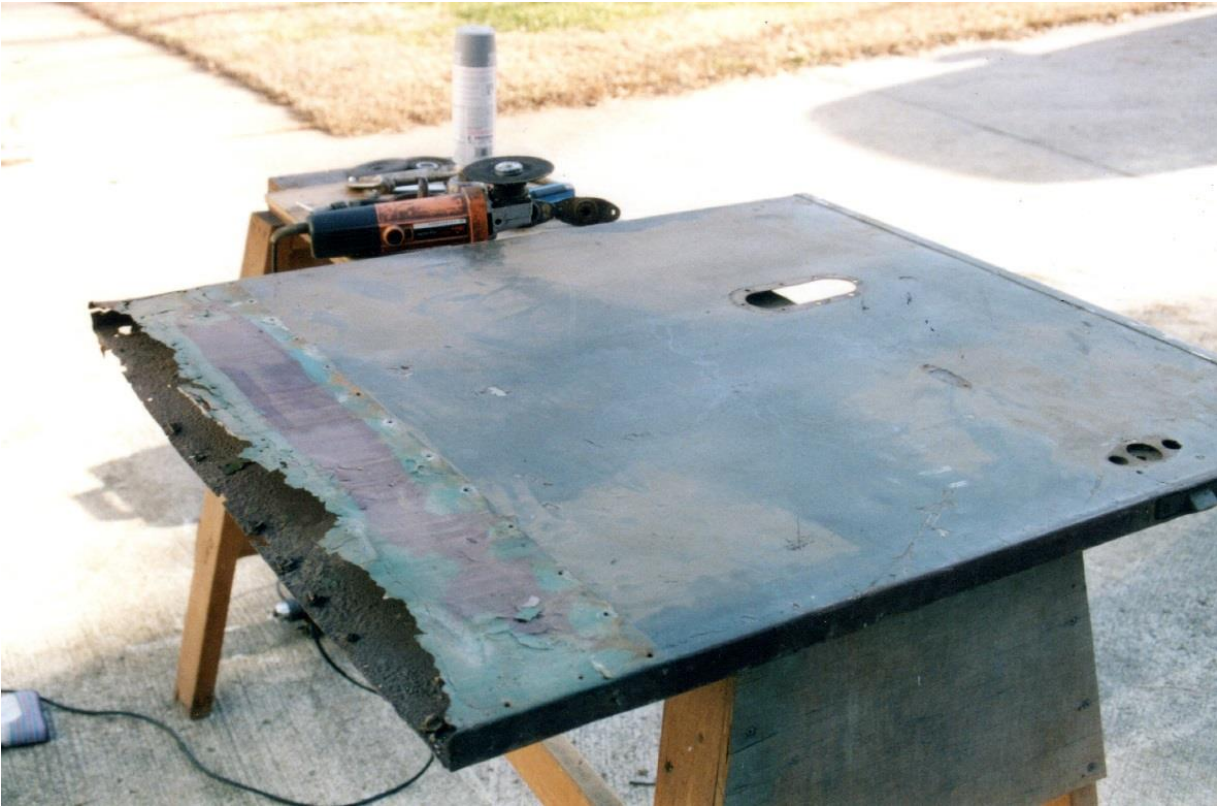
The same Dutch door lower portion at the start of restoration.
