Private Car Annual Inspection Report

Amtrak Car Number	800257	Car Name/Number	Salisbury Beach	Inspection Date	5-19-19 to 55-31-19	Location	30th St. Coach Yard, Philadelphia
Car Type	Sleeper	Year Built	DDec 1954	Amtrak Authorized Inspector	G.F.Payne AMT 90001992	Phone Number	443-994-7212

Substitute MAP-9

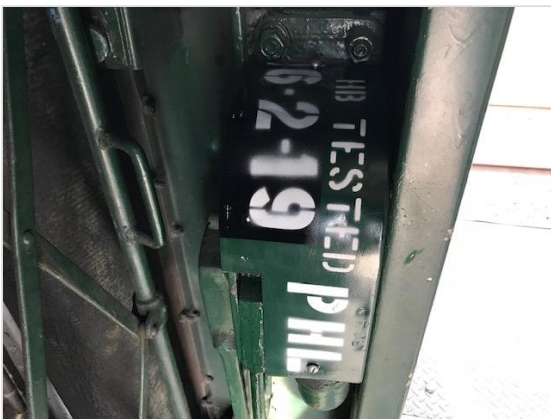
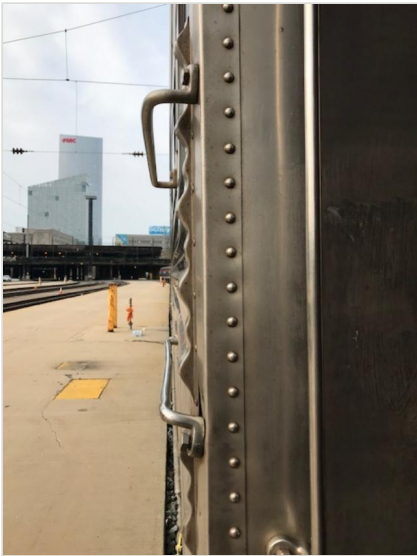
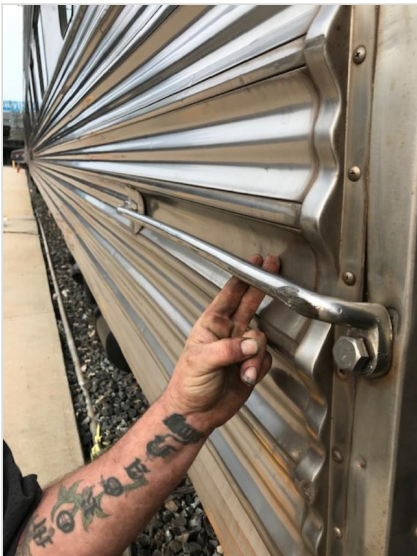
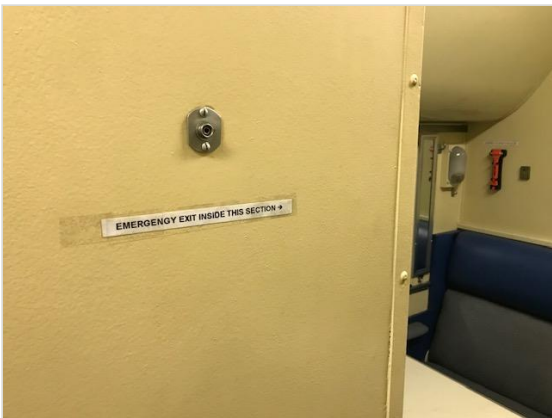
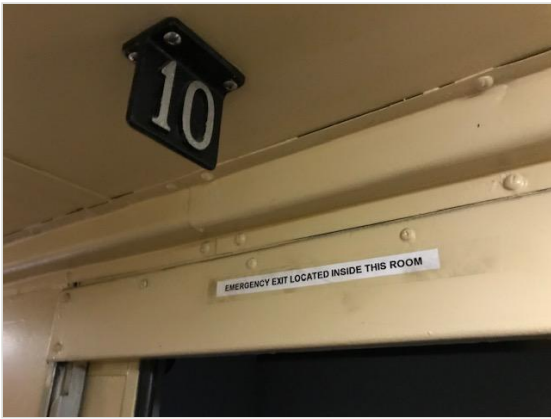
Attached are the photos you requested of the repairs we made during your inspection.

Defect	Repair	Repaired & inspected & Date
1	Peeling "High Voltage" label at transformer bank, right side of car.	<i>Replaced label by owner</i>	<i>OK - 5/31/19 – GFP</i>
2	Broken Microphor waste line (Left side, inboard of 3 wheel). Indications of leakage. Unable to access interior of car to identify which room(s) the line originated.	<i>Capping line leading from toilets – toilet inoperative and line cannot drain on tracks</i>	<i>OK - 5/31/19 – GFP</i>
3	Hand brake stencil indicates out-of-date and requires retest. Restencil date and location of test.	<i>Handbrake inspected, lubed, tested and inspected by owner. See attached e-mail and photograph.</i>	<i>OK – 6/2/19 - GFP</i>
4	Unable to read manufacturer's labels on windows from interior to check if FRA compliant or not, as unable to access interior of car. Could not determine Escape mechanism.	<i>Mixed safety plate and FRA-II. Carbide tipped hammers in two locations on each side of car, with instructions. Notice posted over sleeping compartment doors that escape windows are inside. See attached e-mail and photos .</i>	<i>OK – 6/2/2019 – GFP</i>

10	Lower horizontal hand hold, right side, right side bend w/ less than required clearance	<i>Grab iron removed, heated, straightened and reinstalled. See attached e-mail and photo.</i>	<i>OK - 5/31/19 – GFP</i>
11	Will need an E-mail from the owner or manager stating that since the last PC-1 inspection, the PC-6 and PC-7 have not been changed (no wheels/axles have been changed) and that PC-5 clearances haven't been changed since last PC-1 inspection. Include Amtrak 800000 number and car name.		<i>Received E-mail (see attached) – OK – GFP - 5-31/19</i>
